TARDRUM 1

WORKOVER AND TEST REPORT

18 March 2004

SAMSON-INTERNATIONAL (AUSTRALIA) PTY LTD

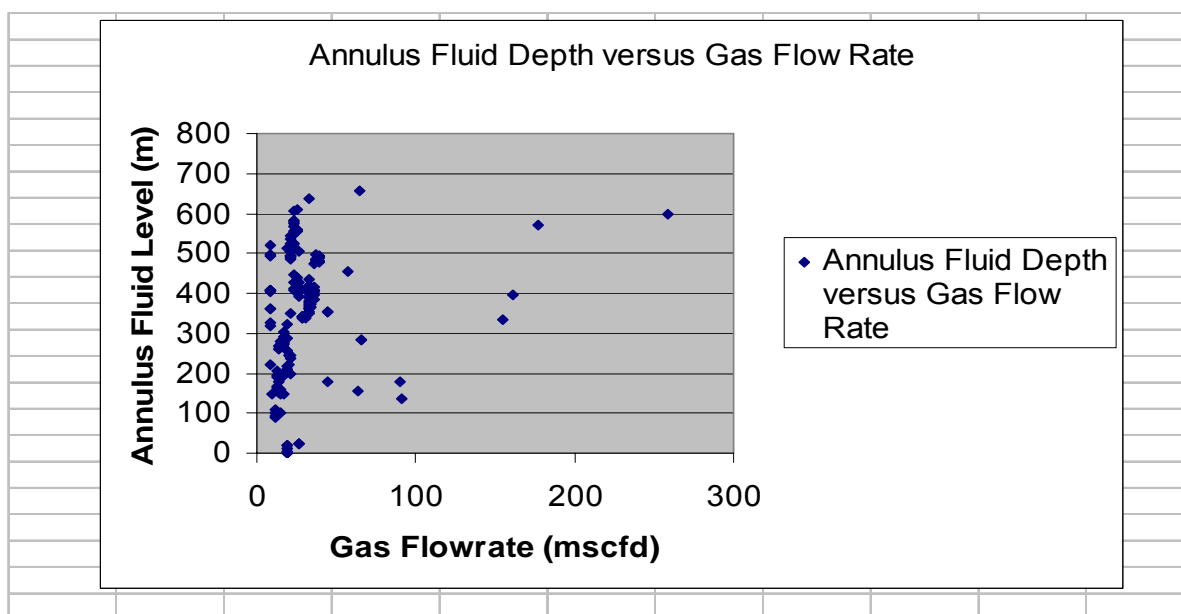
Low gas rates are typically produced from coal seams until the cleat is substantially dewatered, hence it can be concluded that the majority of the gas during test # 2 was produced from the sands. With the fluid level in the well at 495m the produced gas rate from the casing was around 38mscf/d and from the test performed in March 2003 where the water level was below the sands the gas production rate was 64mscf/d. It can be concluded that the absolute open hole flow potential of the gas sands as currently completed is in the range 60-70mscf/d.

The chart below is a crossplot of gas flowrate from the annulus versus the annulus fluid level.
