# BLUE ENERGY LIMITED

2008 INJUNE 2D SEISMIC SURVEY  
FIELD SUPERVISION REPORT

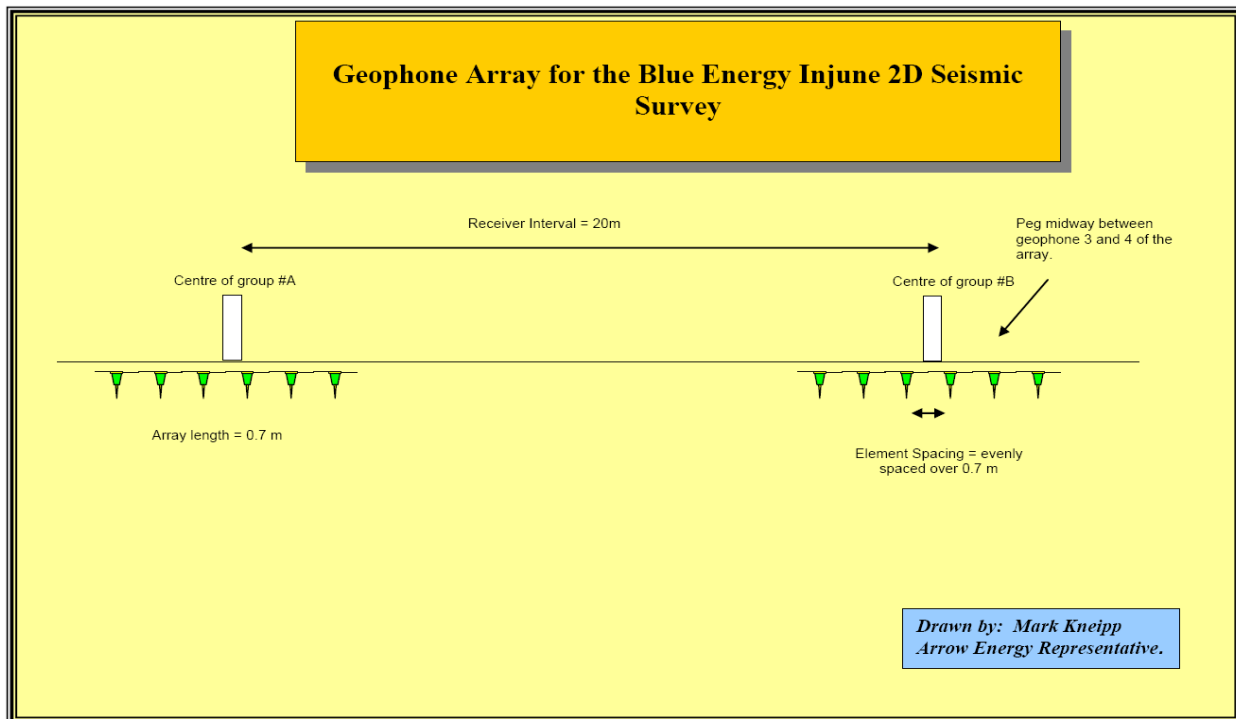
Figure 2: Diagram of Geophone Array

The geophones were positioned in a tight array of 70 cm (a group set) centered on the peg. There were 120 live channels with 20m receiver intervals and 40m source intervals to give a 30-fold coverage. A single vibrator was used with 1x10 second sweep and 4-64 Hz sweep frequency as the energy source.

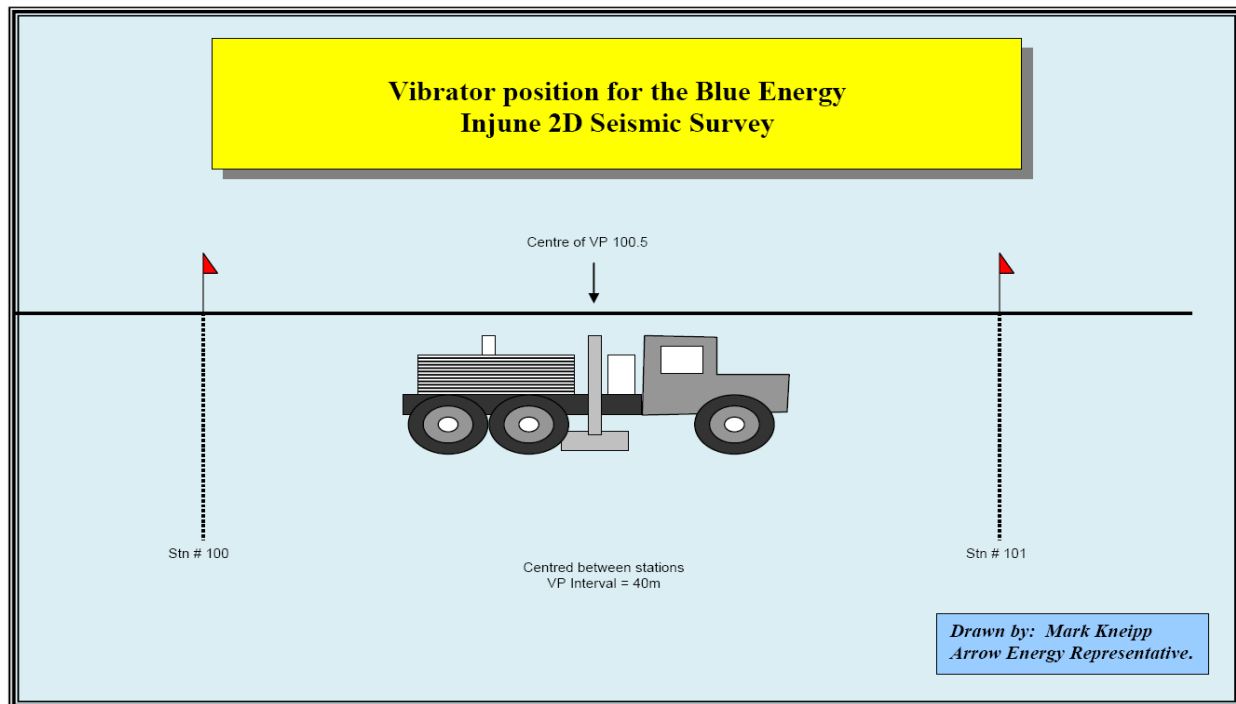
Figure 3: Diagram of Vibe Position

<b>Acquisition Type:</b>	Sercel 428 - 24 Bit Telemetry System
<b>Energy Source:</b>	1 x Hemi 44 44,000lb Peak Force 6x6 Truck Mounted Vibrator
<b>Vibrator Point Interval:</b>	40 metres
<b>Vibrator Array:</b>	Point Source – single sweep
<b>Vibrator Array Location:</b>	Centered between Stations (Centered at SP 100.5)
<b>Receivers:</b>	6 x 10 Hz SM24 Geophones / Group
<b>Receiver Group Interval:</b>	20 metres
<b>Receiver Array:</b>	0.7 metres (6 phones grouped over 0.7 metres)
<b>Receiver Array Location:</b>	Centered on Station Pegs (Centered at SP 100)
<b>No. of Channels:</b>	120 Channels
<b>Spread Geometry:</b>	Symmetric Split Spread
<b>Maximum Offset:</b>	1190_10_0_10_1190 metres
<b>Sweep Length:</b>	12sec
<b>Number of Sweeps:</b>	1 per VP
<b>Sweep Type:</b>	Monosweep
<b>Sweep Frequencies:</b>	4-80 Hz
<b>Sweep Taper:</b>	300 ms Taper
<b>Fold:</b>	30 Fold
<b>Record Length:</b>	3.0 seconds
<b>Correlation Sample Rate:</b>	2 milliseconds

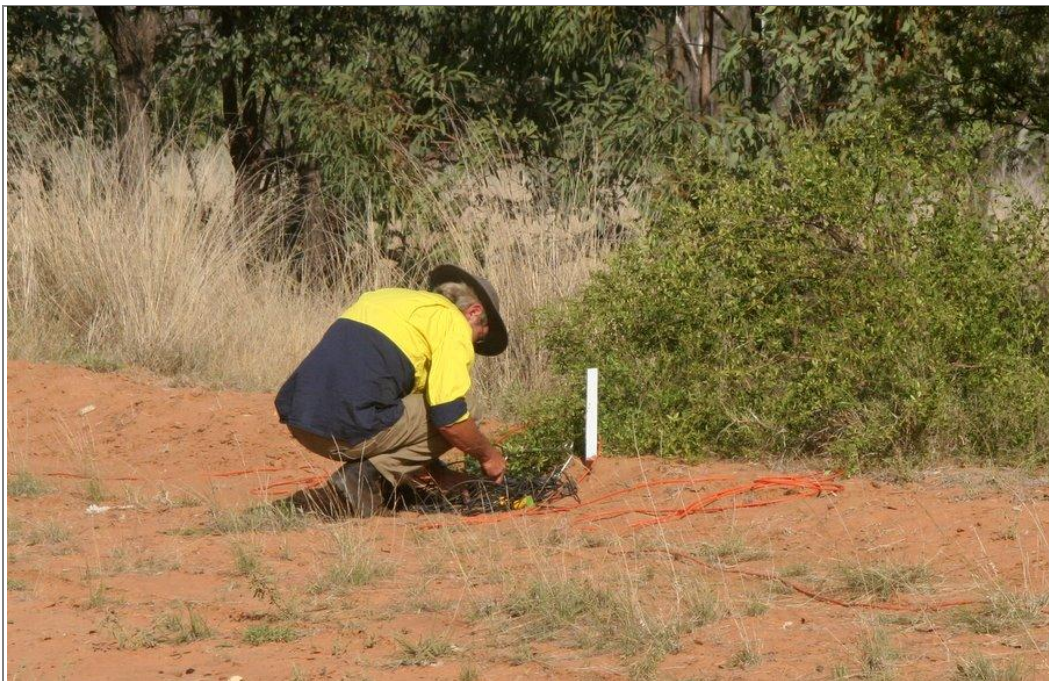
Figure 4: Planting a group set

Terrex provided a Sercel 428XL telemetric recording system, along with a field deployment of 600 x 6 strings of Sensor SM4 10 Hz geophones.

There was one Station Unit (SU) every station and one Line Acquisition Unit (LAUL) and battery unit every 40<sup>th</sup> station. Each cable had 4 takeouts spaced at 55m intervals.

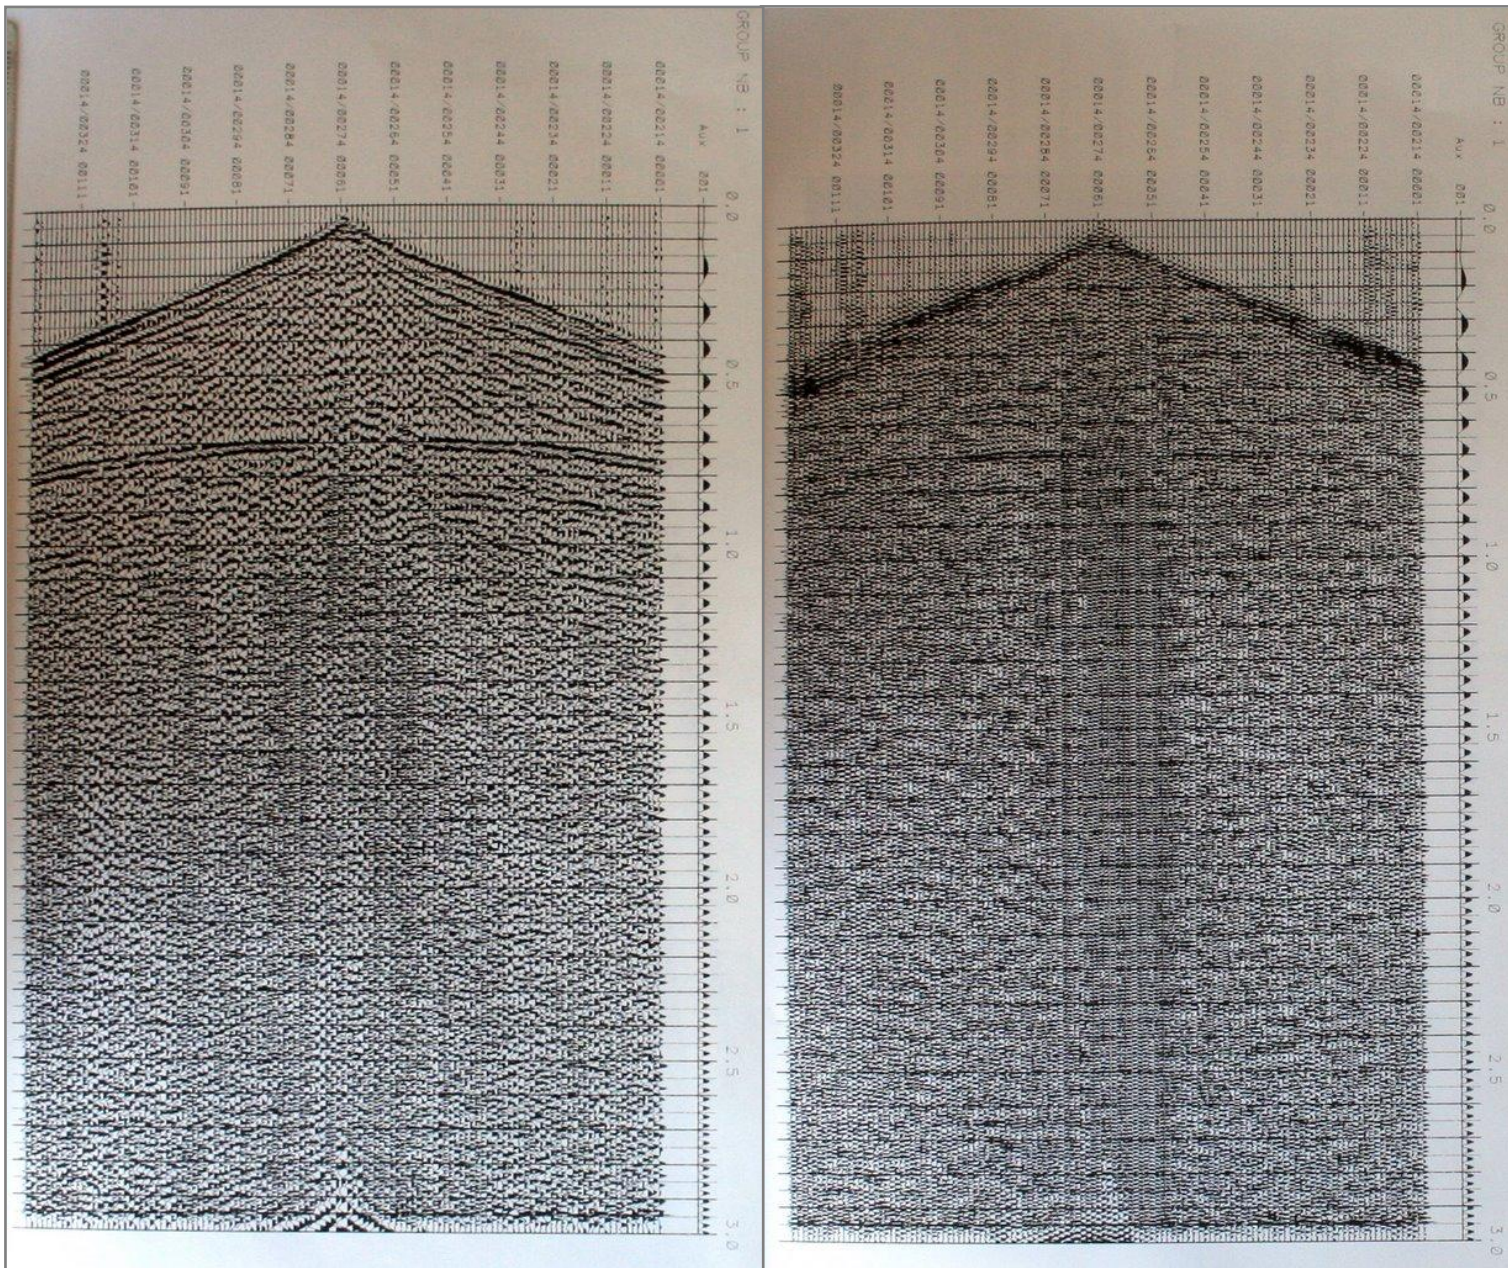
Figure 5: Frequency Filter test  
25 Hz low cut filter (left) VS 60 Hz low cut filter (right)

**Figure 5** shows a comparison of different frequency filters from a test sweep playback. The monitor on the left shows a low frequency filter of 25Hz. The target structure and some weak multiples can be seen, but on the right monitor, most reflectors have been filtered out by the 60Hz low-cut filter. This helped indicate a good frequency range to use as an energy source.

- A sweep frequency test. A single 8 second sweep from 1 vibrator at 90% force was recorded at 4-110Hz and the results plotted with a progressively higher frequency filter. The shot was played back with no filter, 25Hz low cut, 40Hz low cut, 50Hz low cut, 60 Hz low cut & 70 low cut. By the 70Hz filter, most of the target reflectors had dissipated, and a frequency of 4-80Hz was selected.
- Next, a sweep length test was conducted. A single sweep with 1 vibe, 90% force, 4-80Hz, was recorded at 8sec, 10 sec, 6 sec, 12 sec, 14 sec & 16 sec. These were plotted with a 25Hz low cut filter and compared. The 10, 12 & 14 second records all showed similar return at the target time of 0.7 sec, however some deeper structure emerged with the 12 second sweep and this was chosen as the preferred sweep length.

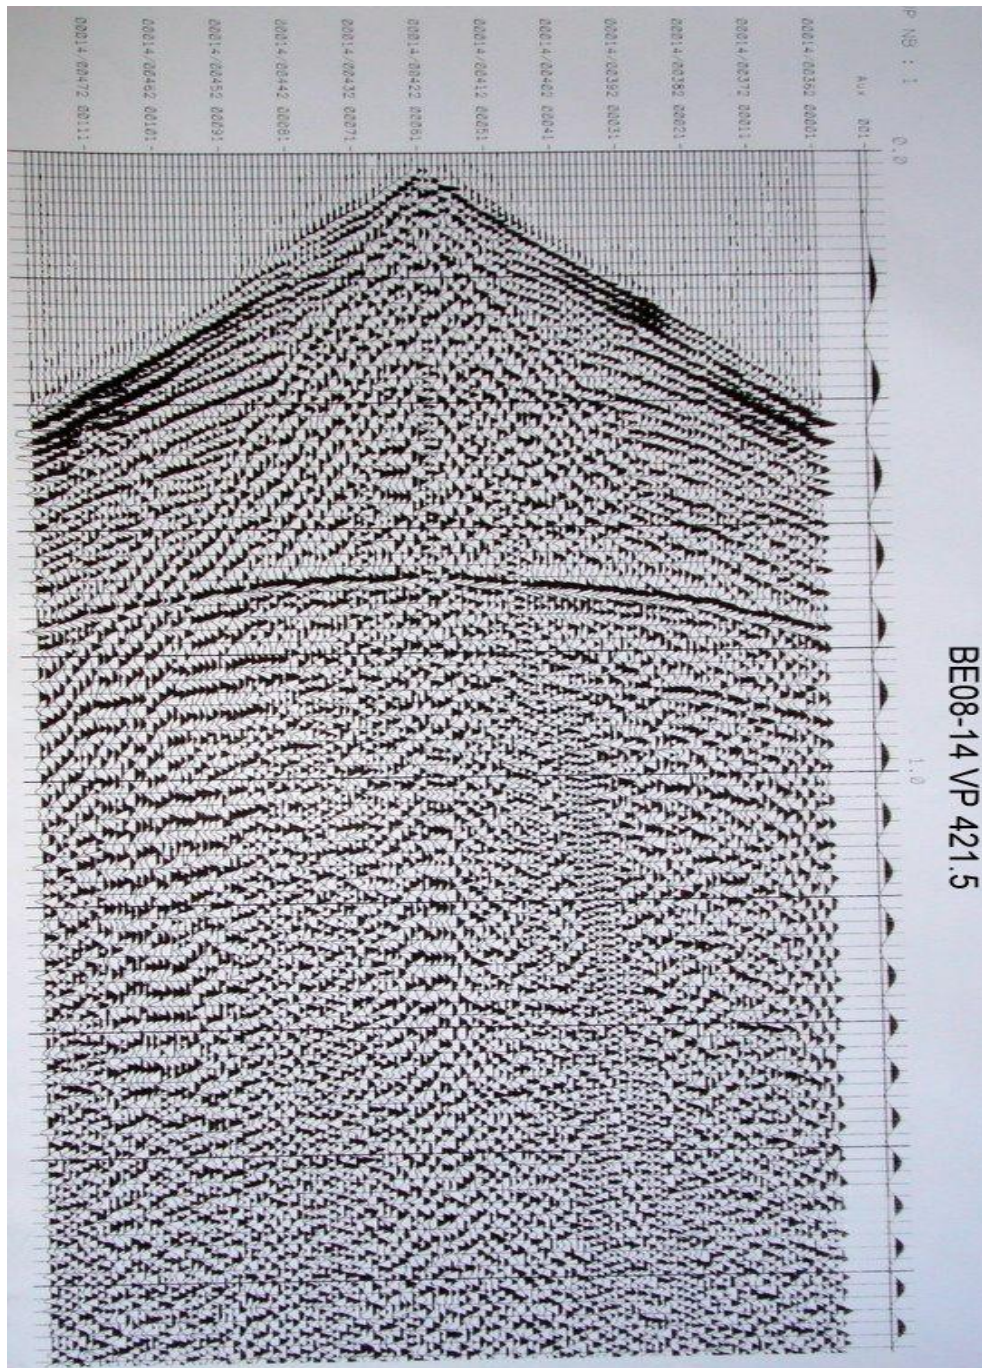
Figure 6: Sample Monitor – production VP

**Figure 6** is from a production shot from VP 421, line BE08-14. It shows a 1<sup>st</sup> break refractor of approximately 2800 metres/sec, good shallow reflection, a strong reflector at the 700 ms target and some weaker data below this. It must be noted that this sample monitor record has a 25 Hz low cut playback filter applied to them. The observers do this to cosmetically clean up the record and make it easier to trouble shoot. But the effect is to mask the lower frequencies and, in particular, the full impact of ground-roll.

Line BE08-14 VP 421

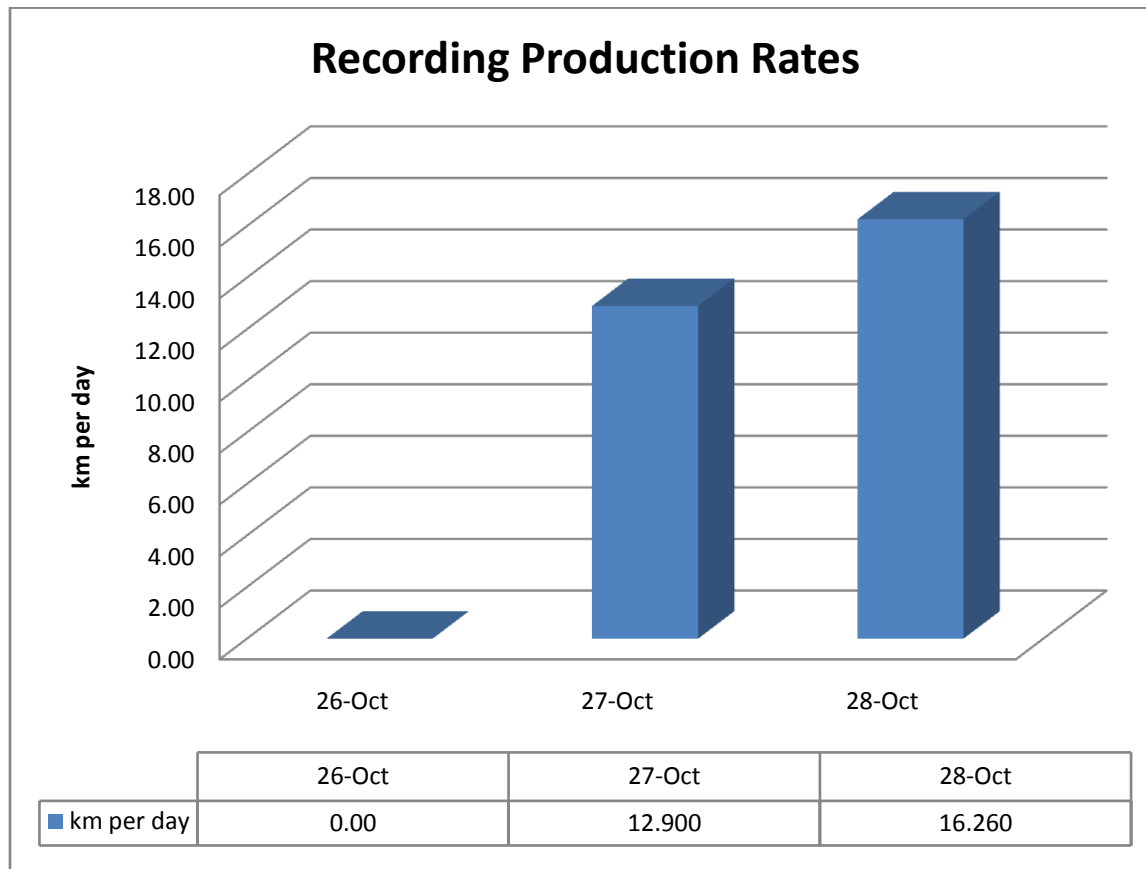
**Figure 8: Recording production**

**Figure 8** below details daily production in the 2008 Injune Seismic Survey:

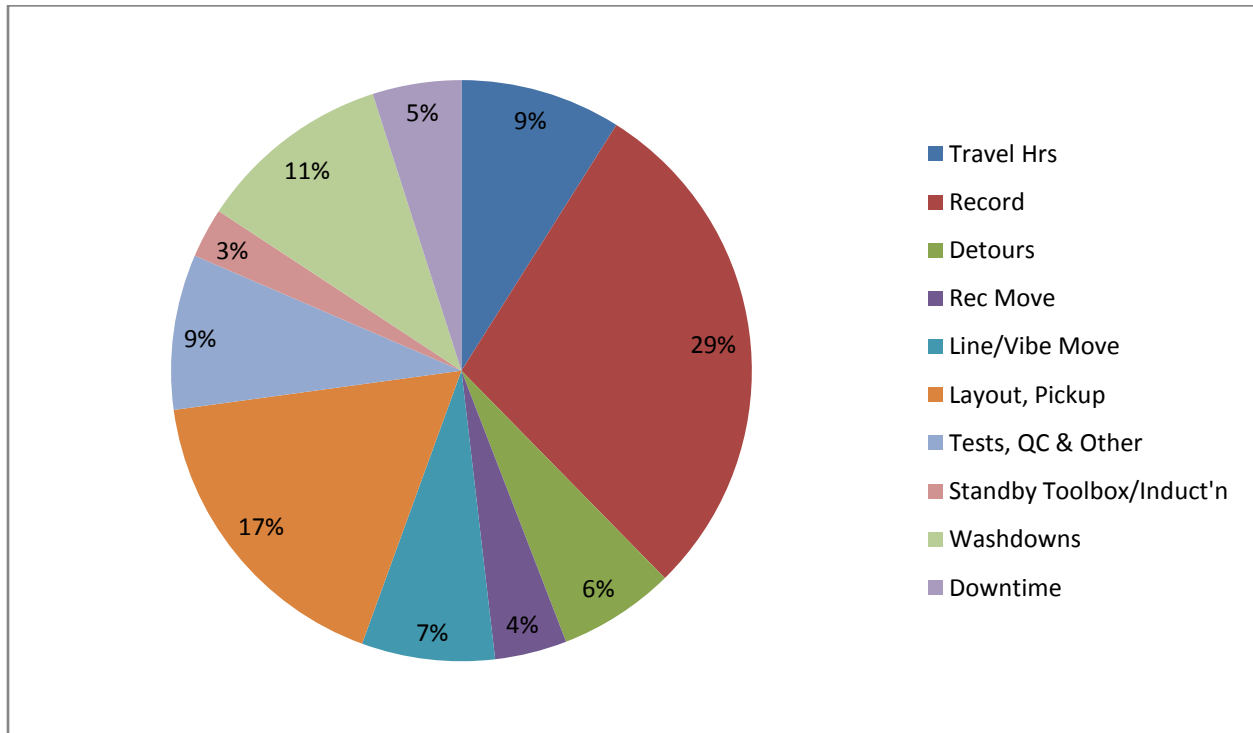
**Figure 9 Distribution of job hours**

The pie chart above shows that 29% (9.3 hrs) of total time was spent recording. The only non-production time of note was equipment layout and pickup time (17%, 5.6 hrs). Note mobilization times (4.0 hrs) have not been included in this chart.

These figures indicate standard times for a survey like the Injune 2D; often preparation time (wash-downs, spread layout, testing and pickup) consume a large portion of a small job's time.

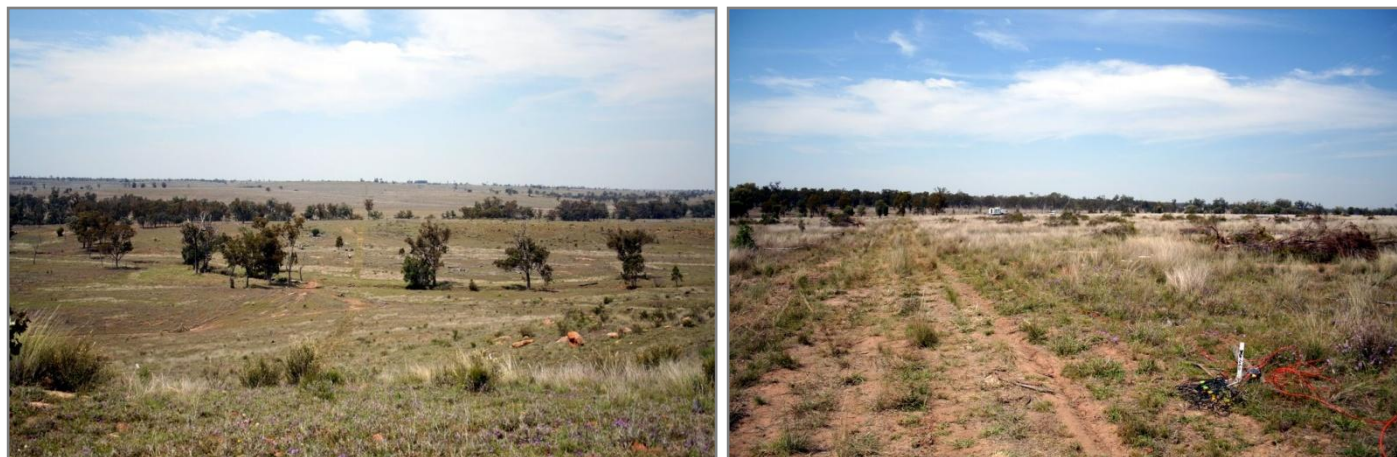
**Figure 13: Examples of the terrain on prospect**

The Injune prospect consisted of undulating lithic sandstone and shale hills. A scarp ran East-West on the northern side of the prospect, intersecting lines BE08-15 and BE08-14.

Most of the land has been cleared and grassed for cattle grazing, although some small stands of mixed eucalypt woodland remain, mainly on steep terrain or within the boundaries of the Injune and Horse Creek systems.
