PINELANDS 2012 SEISMIC SURVEY

FIELD OPERATIONS REPORT

ATPs 574 & 632

SURAT BASIN, QUEENSLAND, AUSTRALIA

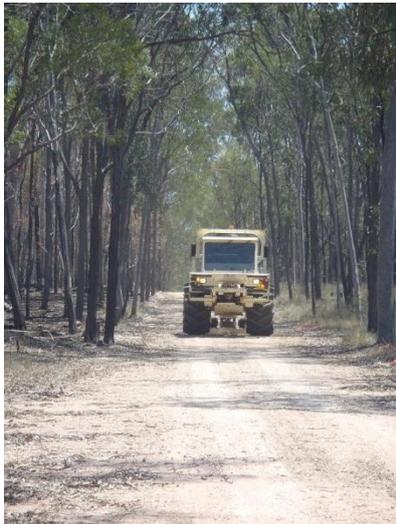
Picture 2: Vibrator working along minor road in Pinelands area

The lines were recorded using a vibrator as the source; the vibrators worked in two fleets of a single vibe in each fleet with the source fleets were separated by 1km. The vibrators used were AHV-IV with 60,000lb peak output, running at 80% drive. A single sweep was used for vibe points.

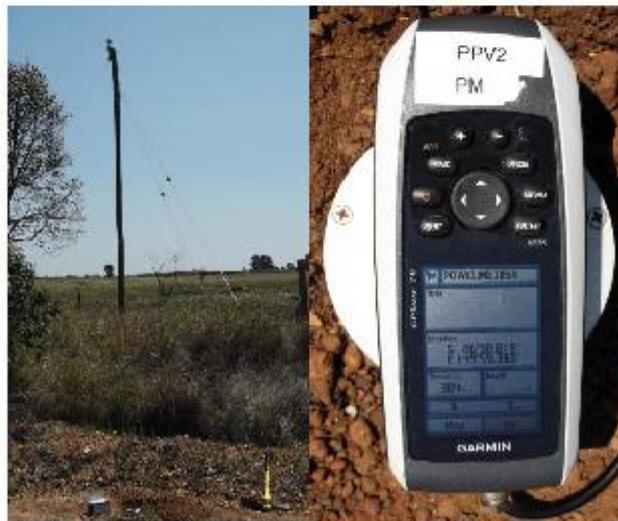
Crew **GEOKINETICS CREW 488**
Client **QGC**
Project **BELLEVUE – PINELANDS 2012 - 2D**
PPV Device **InstatelMiniMate Plus**
Structure **POWERLINE**
Time & Date **07:41 – 08:14 / 20 October 2012**
Seismic Source **Vibroseis (AHV IV)**

Coordinates: S 26° 30.818' E 149° 59.383'

LINE	VP	PVS (mm/s)	DISTANCE (m)	COMMENTS	VP Time
PIN12-119	1870		87	No Trigger	9:11:14
PIN12-119	1869		78	No Trigger	9:49:26
PIN12-119	1868		67	No Trigger	9:12:40
PIN12-119	1867		57	No Trigger	9:50:10
PIN12-119	1866		48	No Trigger	9:13:20
PIN12-119	1863-1865			Skip Powerline	
PIN12-119	1862	1.37	13		9:14:07
PIN12-119	1861	1.58	13		9:51:50
PIN12-119	1860	0.66	19		9:15:47
PIN12-119	1859		27	No Trigger	9:52:50
PIN12-119	1858	0.54	36		9:17:05

Where 'sensitive receptors', such as houses, barns, pipes etc were encountered along the lines, the crew took Peak Particle Velocity meter readings to ensure that levels of vibration induced by the vibrators were within international tolerances. These PPV readings were planned in advance based

on information from aerial photography, satellite imagery and notes from the surveying teams. The line trace maps produced by the crew included details of where PPV readings were to be taken, to simplify the process for the line crew. There were not many readings required in the Pinelands area, and most were in the proximity of power poles.

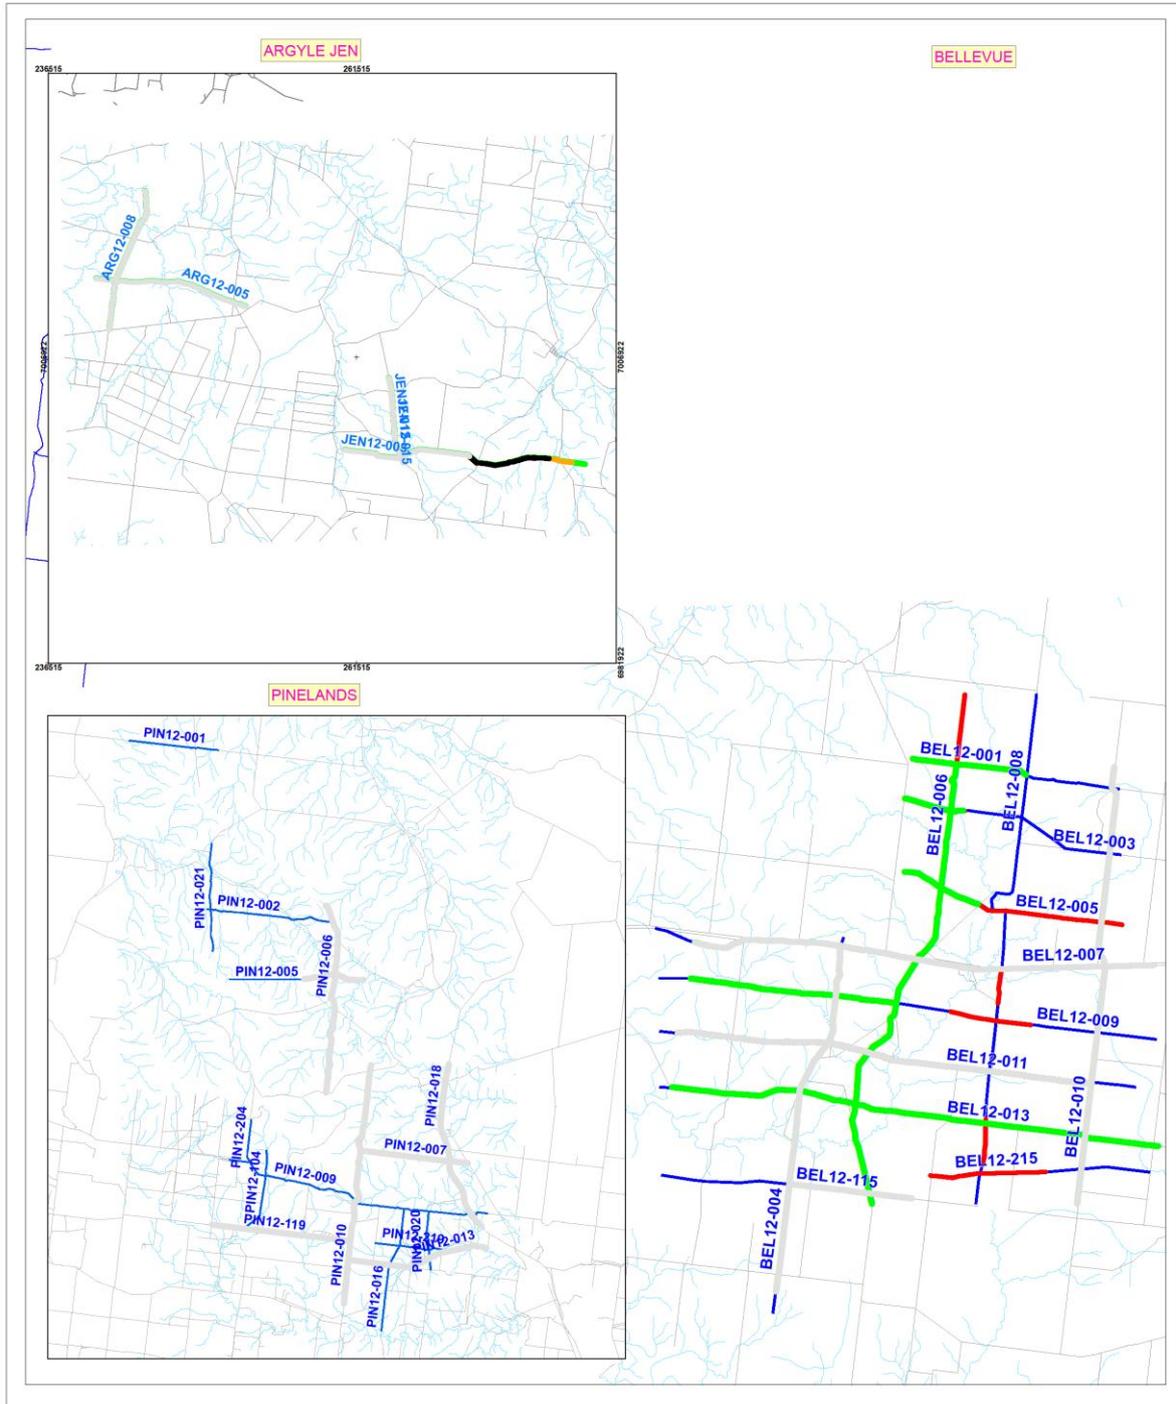
Progress Map (example from mid-way through the project)

Bellevue/Pinelands/Argyle Jen
2D Seismic Survey

17th November 2012
