Geokinetics (Australasia) Pty Ltd

FINAL REPORT

2012 Bellevue-Pinelands-Jen&Argyle 2D Seismic Survey

CLIENT	:	QGC Pty Ltd
AREA	:	Surat Basin, Queensland
Contract	:	Reference No. 114767CNT – Amendment #1
COUNTRY	:	Australia
DATE OF SURVEY FROM	:	24 September 2012
DATE OF SURVEY TO	:	13 December 2012
DATE OF REPORT	:	8 January 2013
METHOD OF SURVEY	:	2D Land – Reflection Seismic Survey

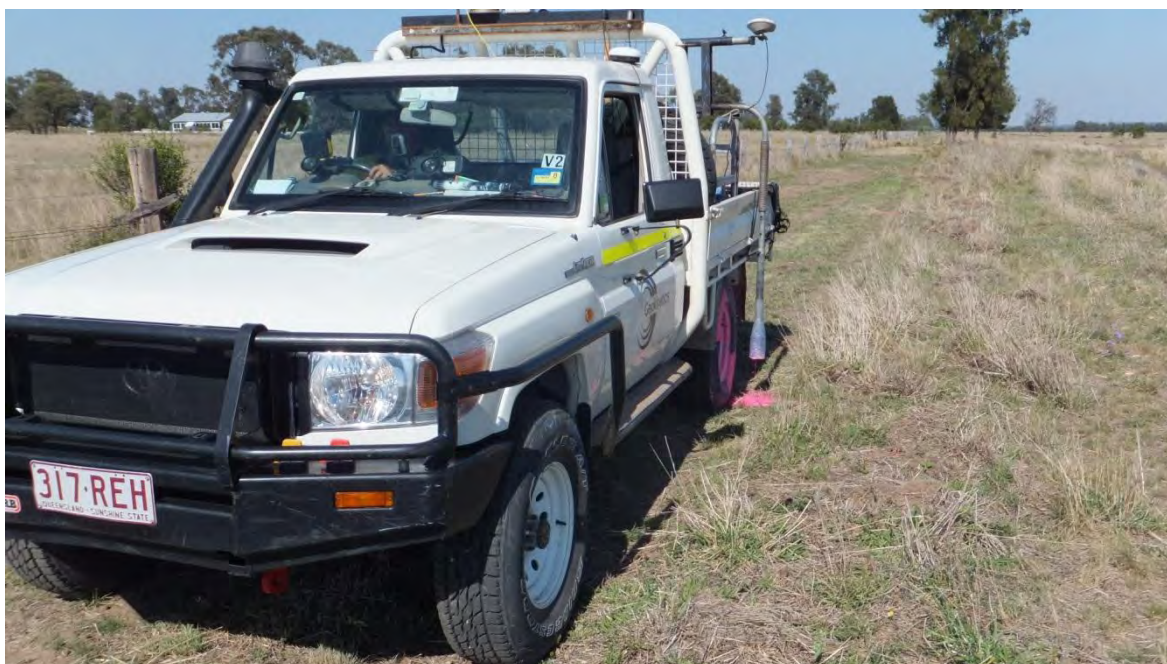
Figure 6. Degradable paint spraying machine mounted below GPS antenna

Receiver positions were marked by water base spray paint (canning) or degradable paint marker with spraying paint machine that paint sprayed to the ground. This spray paint system is peg less marker and environment friendly. Geophone receiver layout crews using GPSMAP78 handheld GPS to find receiver position and relationship number of the paint marker.

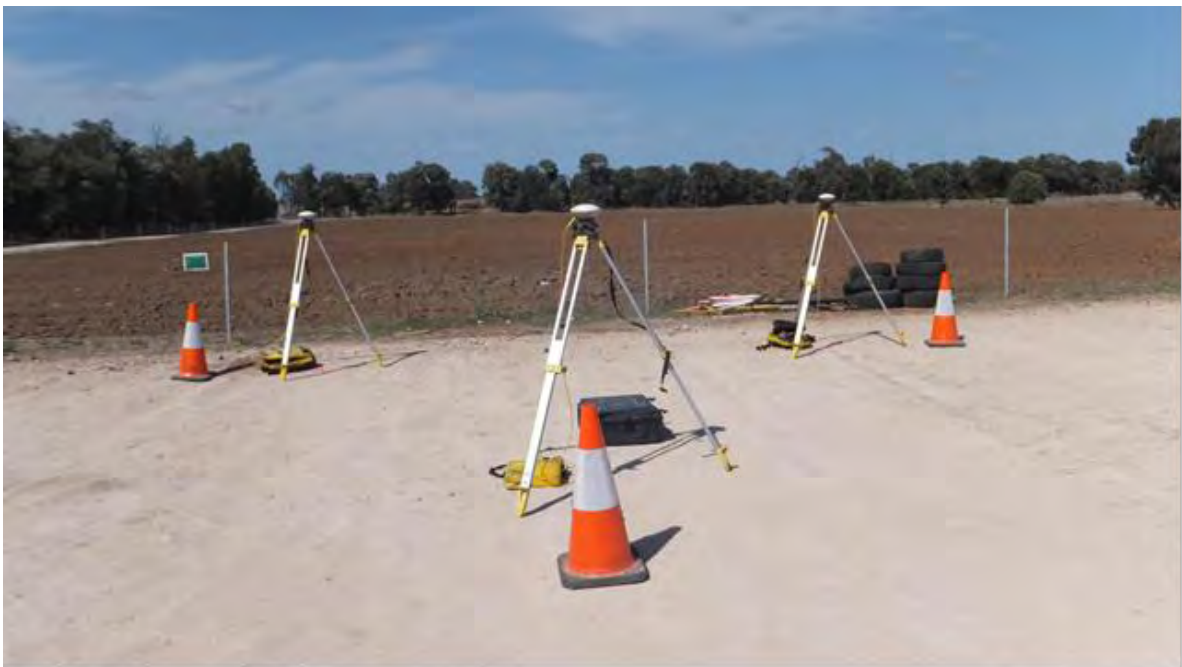
Figure 7. Trimble R7 Receiver Verification at Tasmania Base Camp

A measured 5m by 5m square was set up and one point in the middle and the distances between the points measured accurately with a measuring tape. The GPS units were then set up on the same time at five points logging data.

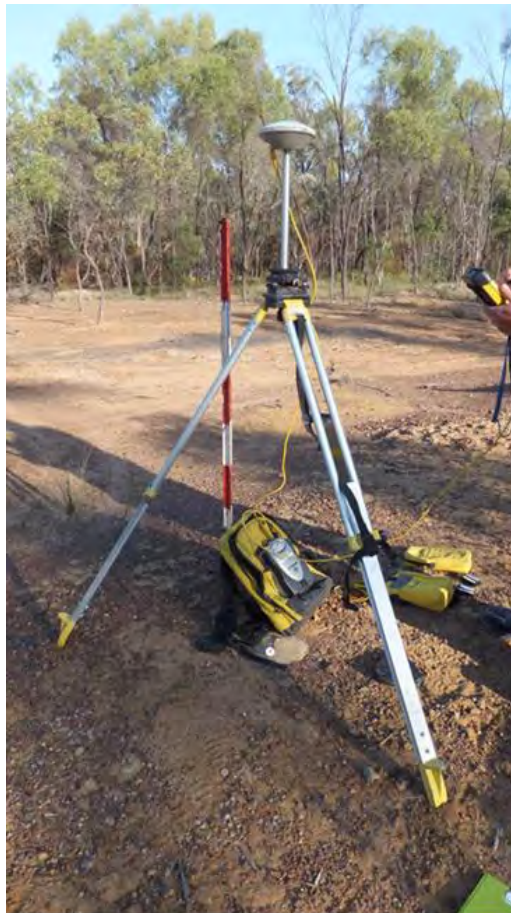
Figure 8. Static observation on 185028 national control network

The project's control station was tied to Australian national survey markers. The survey markers coordinate and information could be found on the website:

The project Coordinate system: GDA94 datum and MGA zone 56 S projection, AHDA vertical datum, and AUSGEOID98 geoid model.

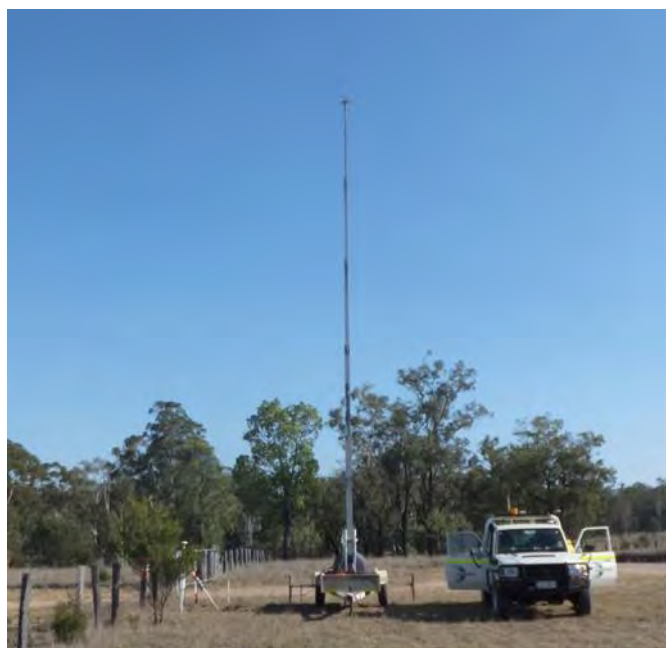
Figure 10. RTK base station at PIN05

Permanent survey markers that were established during the control survey were used as RTK base stations. Check readings were observed on previously surveyed points at the start and end of each working day and after each initialization, to verify correct system operation. Check readings confirmed that the radio link was working; that the proper coordinates had been used at the base; that the proper instrument heights had been entered at the base and rover and that the resolution of ambiguities was correct. All check and repeat observations were compared with known and previously surveyed results and monitored.

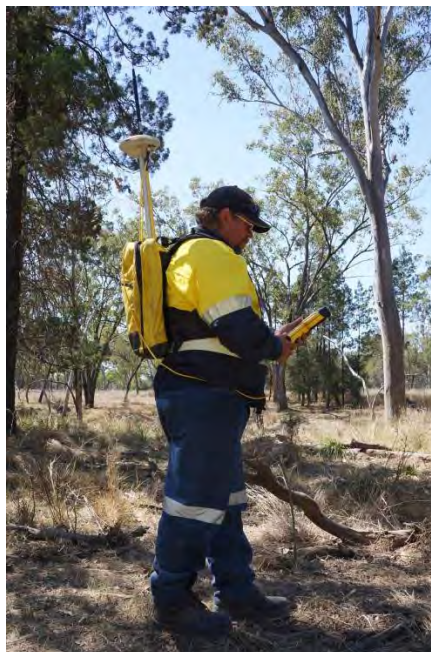
Figure 11. RTK survey by backpack

Some of the seismic 2D lines crossed environmentally sensitive zones. Vibroseis points offsets and path detours were carefully selected through these zones. For such zones, the Crew also deployed the environmentally friendly seismic source; Geokinetics proprietary onSEIS, to manoeuvre through narrow sectors of the seismic lines as an alternative/infill to the Vibroseis where possible. Backpack RTK surveys were deployed within the sensitive areas.

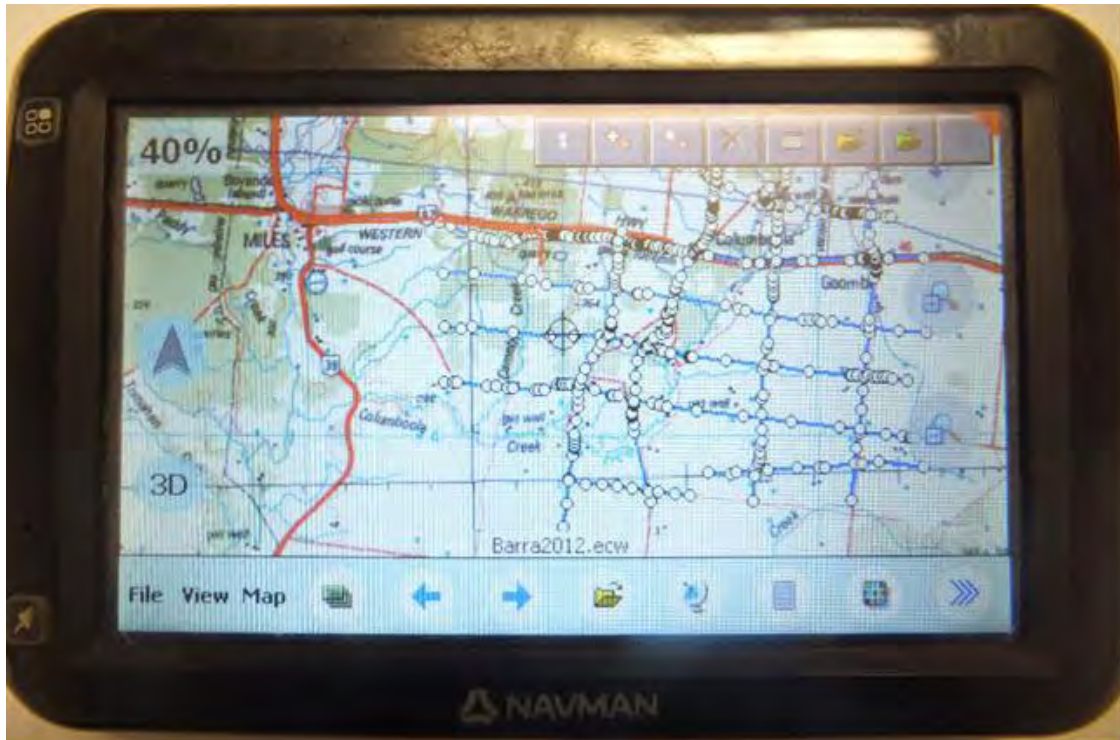
Figure 12. Crew 488 standard vehicle navigation system

Preparation and updating the project's map onto the Crews' vehicles Garmin and Navman navigations system was a daily routine. Postplot source and receiver positions, fences, gates, protected zones, hazards and detour routes were uploaded on the navigation

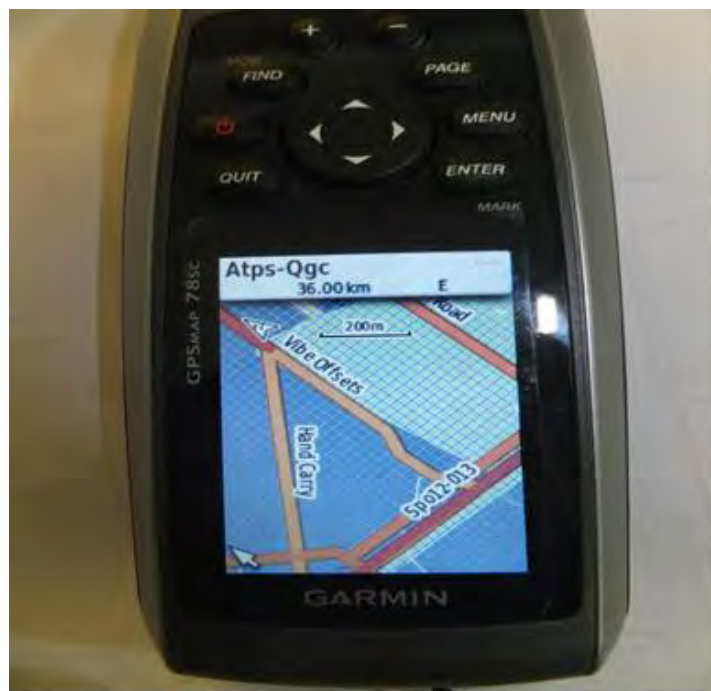
Figure 13. Garmin Navigation system for all crew

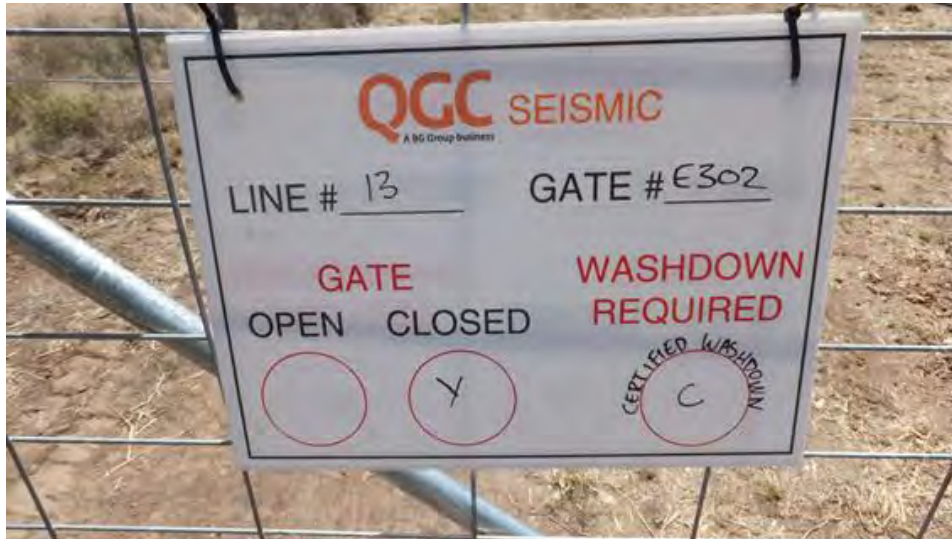
Figure 14. Well-marked access gate

The main challenges of this seismic operation were to follow the seismic lines access rules and vehicles/equipment wash-down. There was limited access to the paddy areas, in addition to the project's requirement for a certified wash or weed and seed to enter most of the properties within the survey area. Access to properties was strictly limited to certain gates with a special QGC sign posted at the gate. The survey advanced party erected these signs based on the Client's instruction.

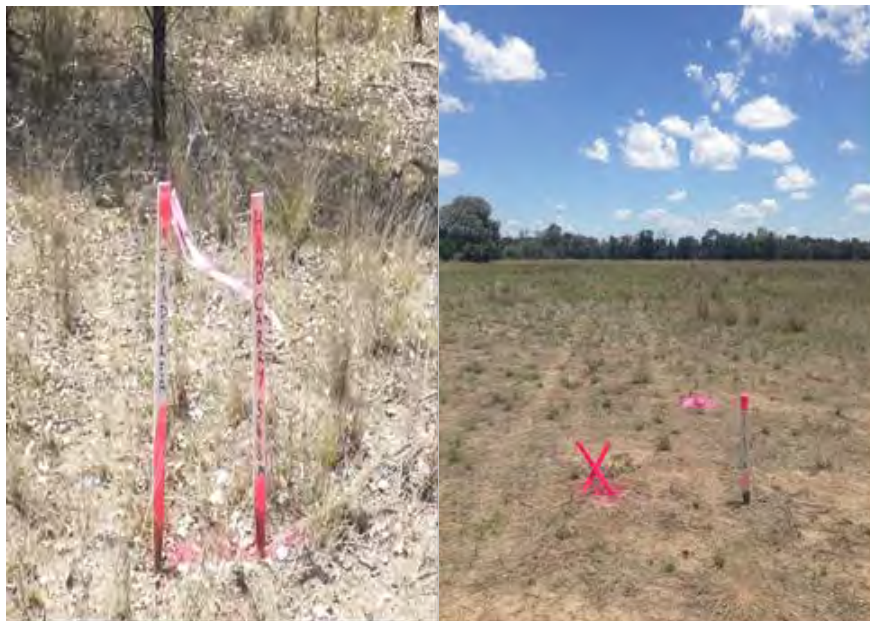
Figure 15. Hazards marks and a hand carry section

Most of the seismic lines required slashing or mulching as a preparation before the seismic operation. Environmentally sensitive zones where line preparation was not allowed; detours and line offsets were implemented. Detour signs and other hazards marks such as pot holes, boggy patches; were established on the ground to assist the other crew members.

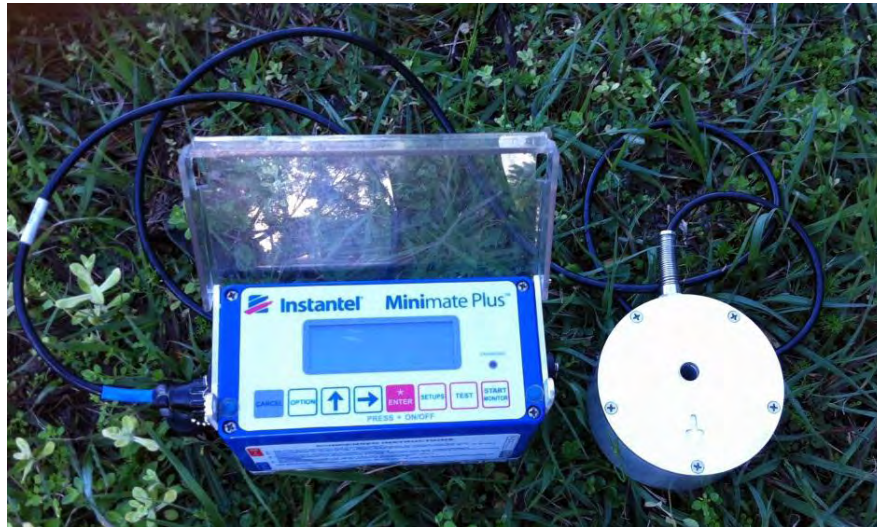
Figure 19. Crew 488 MiniMate Plus unit

According to the signed contract, Crew 488 deployed two calibrated and tested Instantel MiniMate Plus units. Additional two real time PPV monitors were requested by the Client Representative and two Textel GTM / ETM monitors were deployed for the operation. Trained PPV operators joined the field crew throughout the project's duration equipped with the required software and hardware to implement peak particle velocity (PPV) tests.

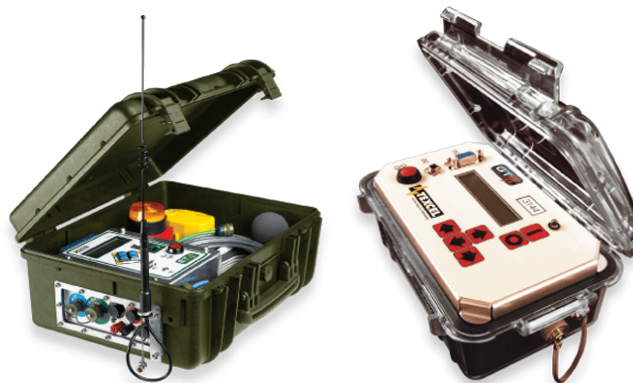
Figure 20. Real Time Textel ETM and GTM PPV monitors

Peak Particle Velocity generated by the project's seismic source were monitored on selected sites, initially to estimate the operating safe distance to the seismic source and then to monitor the PPV values along sectors of the 2D lines close to manmade, natural structures, infrastructures and buildings for future references if required. All PPV testing activities were strictly supervised by QGC onsite Client Representatives. Using the project's logistic / mud map, the Client Representatives decided on PPV sites selections; test duration, test configuration and layout. Crew 488 PPV test operator conducted the tests then provided the acquired PPV data and analysis to the Client Representative.

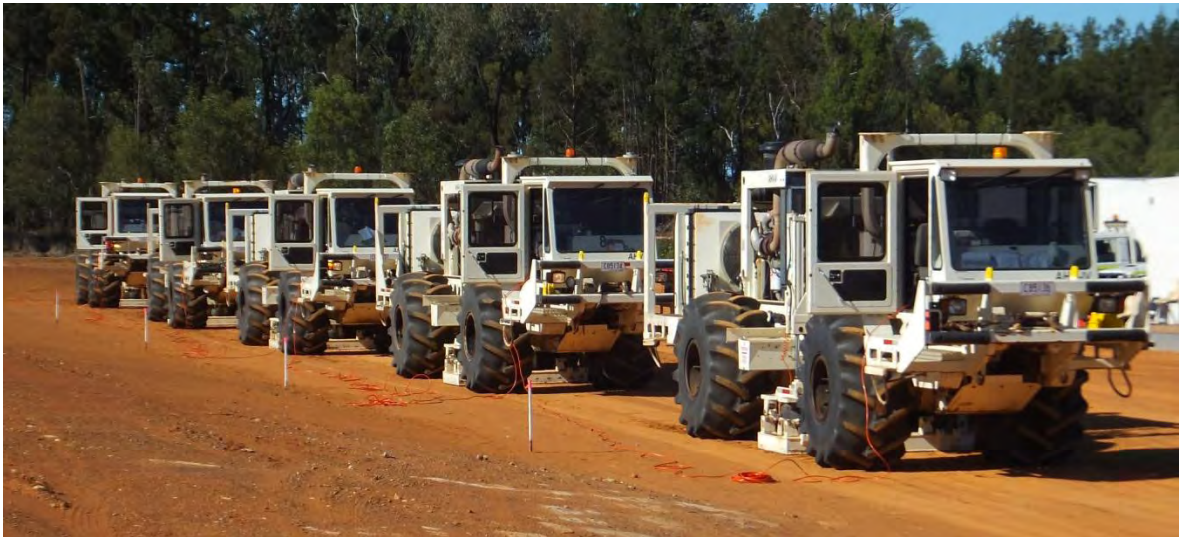
Figure 22. Crew 488 Vibroseis Units at star-up test

The energy sources used for 2012 Bellevue-Pinelands-Jen & Argyle 2D seismic survey were five I/O AHV-IV (60,000 pound) vibrators units in addition to five Geokinetics proprietary Dual onSEIS units. The vibrators were out fitted with Sercel VE 432 vibrator electronics (DSD) and the onSEIS were fitted with SGD-SP synchroniser with seismic source TDMA decoder.

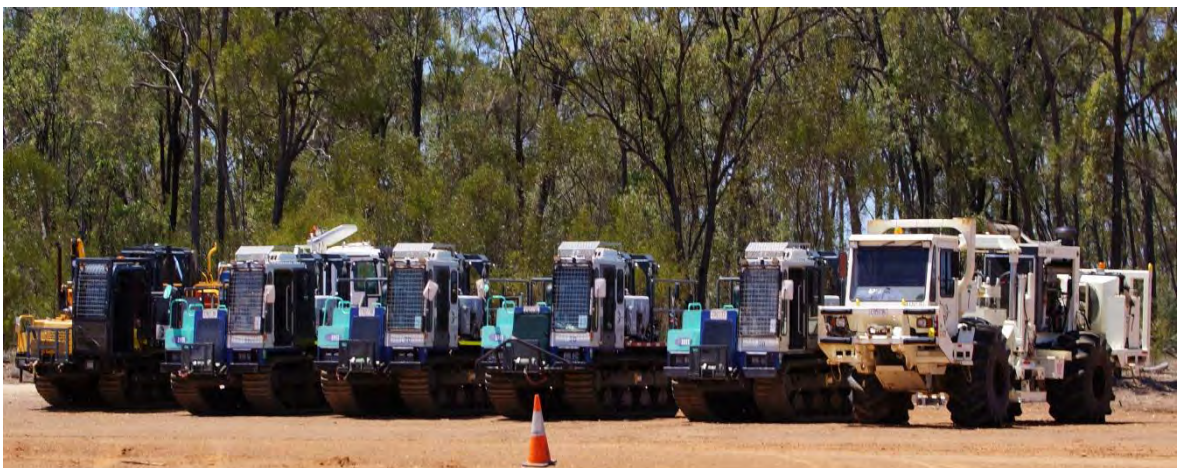
Figure 23. Crew 488 onSEIS Units next to a Vib

Five Vibroseis and five Dual onSEIS units were used as seismic energy sources during data acquisition. The final source position was calculated to the centre of gravity (COG) that was located at the centre of the vibroseis base pad or in the centre of the onSEIS two units. All source units (Vibroseis and onSEIS) were equipped with navigation systems. The system consisted of a differential GPS receiver that receives corrections from satellites and an integrated navigation system (INS) display. GPS NovAtel Propak-V3- XP G2system received differential GPS from the wide-area differential GPS satellite network, OmniSTAR. The Vibes and onSEIS units were also fitted with Garmin GPSMap 3206, a display unit which shows topographical features, source unit position and pre-plot shot point locations.

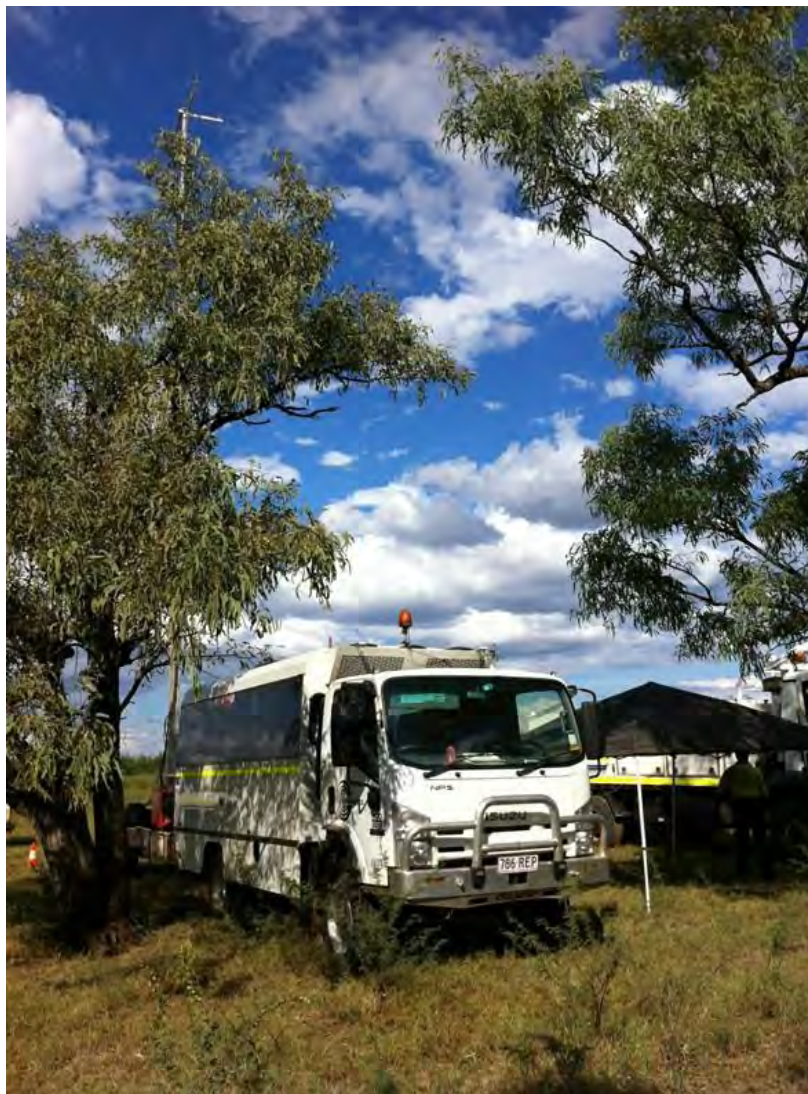
Figure 24. Crew 488 Recorder and Radio Tower

The recording system used for the survey was a 428xl (Line Controller Interface Unit 924439) manufactured by Sercel. The recording system was interfaced to a Sercel VE432 encoder (DPG) which initiated recording, provided QC for vibrator performance, and loaded parameters into the vibrator control electronics. Field hardware was comprised of 1500 Sercel 408 FDU (Field Digitizing Units). 1500 I/O SM-24 “6 x 1” geophone strings were utilised by the field crew.

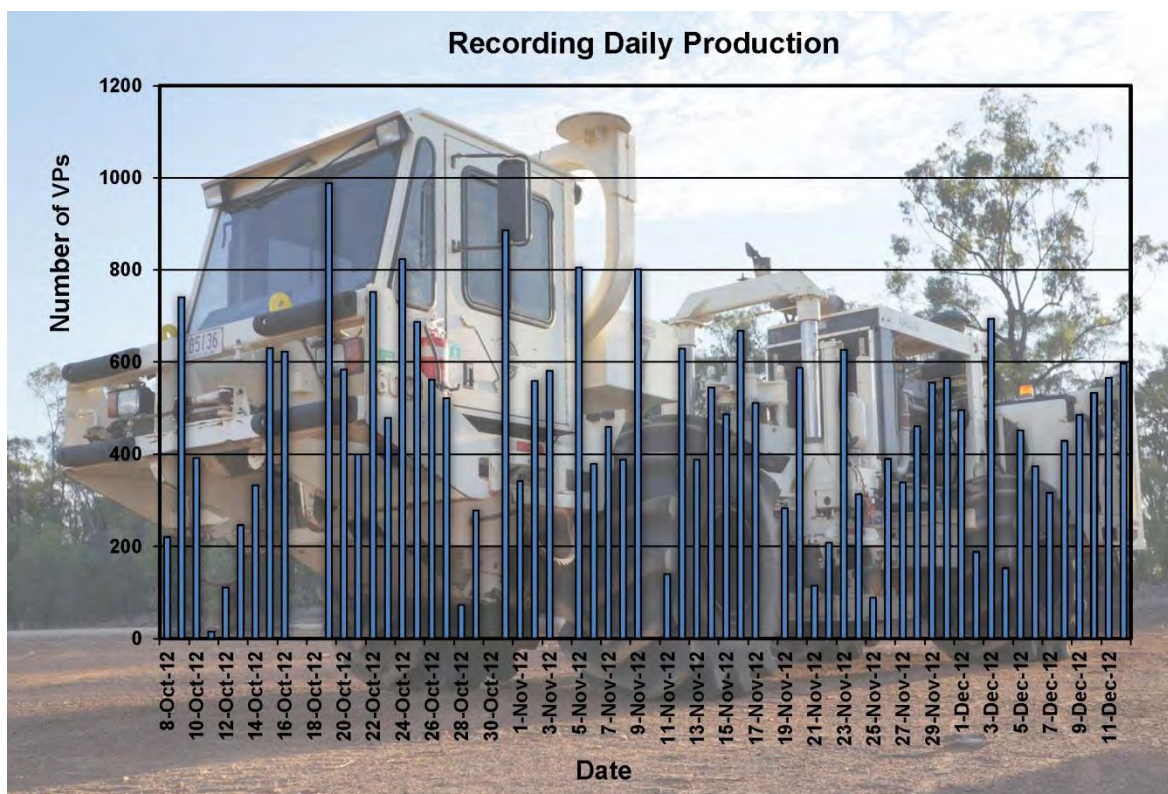
Figure 35. Recording daily production histogram

Project’s total acquired Vibroseis Pints was 27,836 with an average daily production of 422 VPs per day.

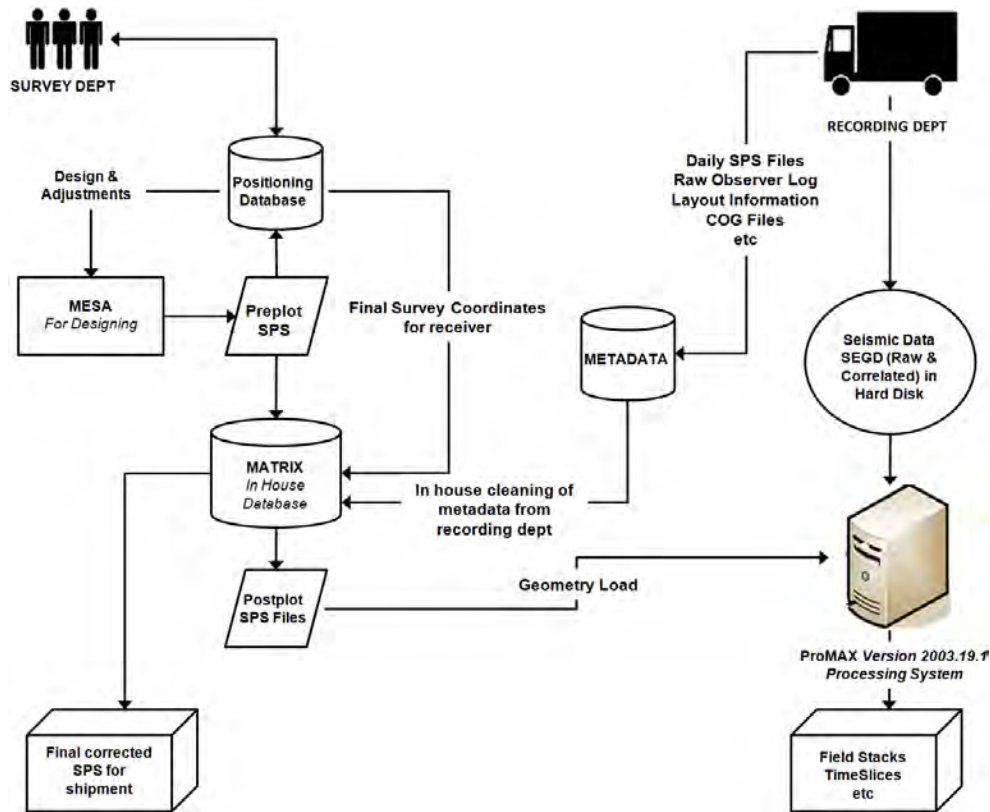
Figure 39. Geophysics Department Data Flowchart

The Geophysics department interacts heavily with both Survey and Recording departments. Data QCing operations began, in conjunction with the survey department, refining theoretical preplot coordinates and defining source and receiver offset guidelines.

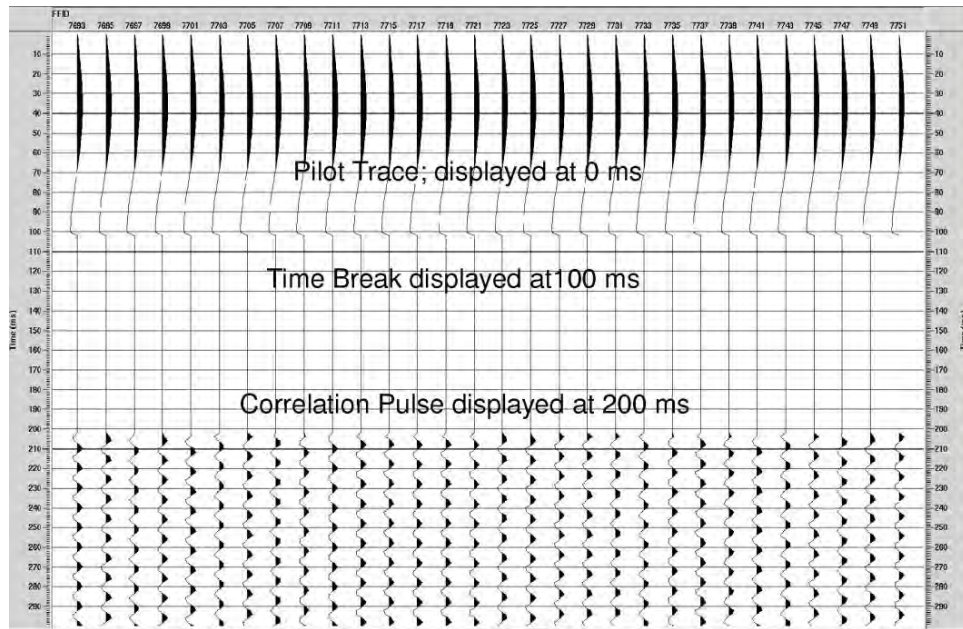
Figure 40. Example of time break auxiliary channel display – Vibroseis

The Auxiliary channels of all acquired field records were QCed and checked on ProMax display tool.

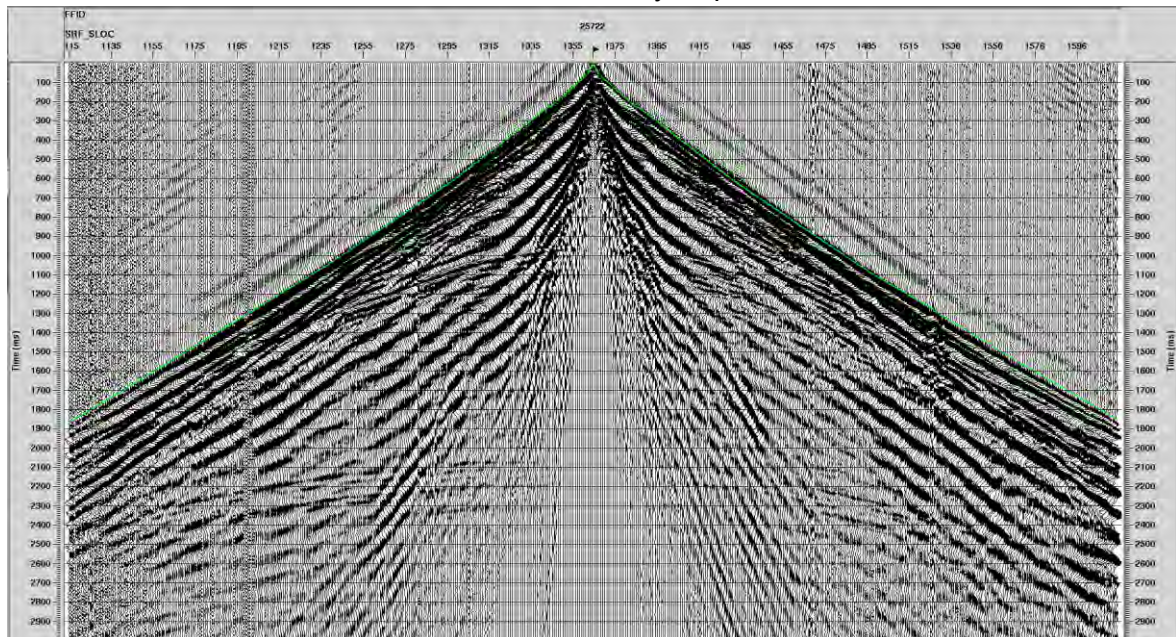
Figure 43. Geometry Applied shot gather with a geometry check gate

The geometry information from the SPS files was loaded to ProMax database and to the field data to create a seismic dataset with geometry loaded in the headers (often referred to as “geometry dataset”). The log file “ProMax output file” produced by the “Apply Geometry” flow was inspected to ensure all the valid records and all their channels were properly matched to the database information. The total number of traces in the dataset was also checked. A geometry applied gate was used to check the final coordinates of sources and receivers as received from the Survey Department.

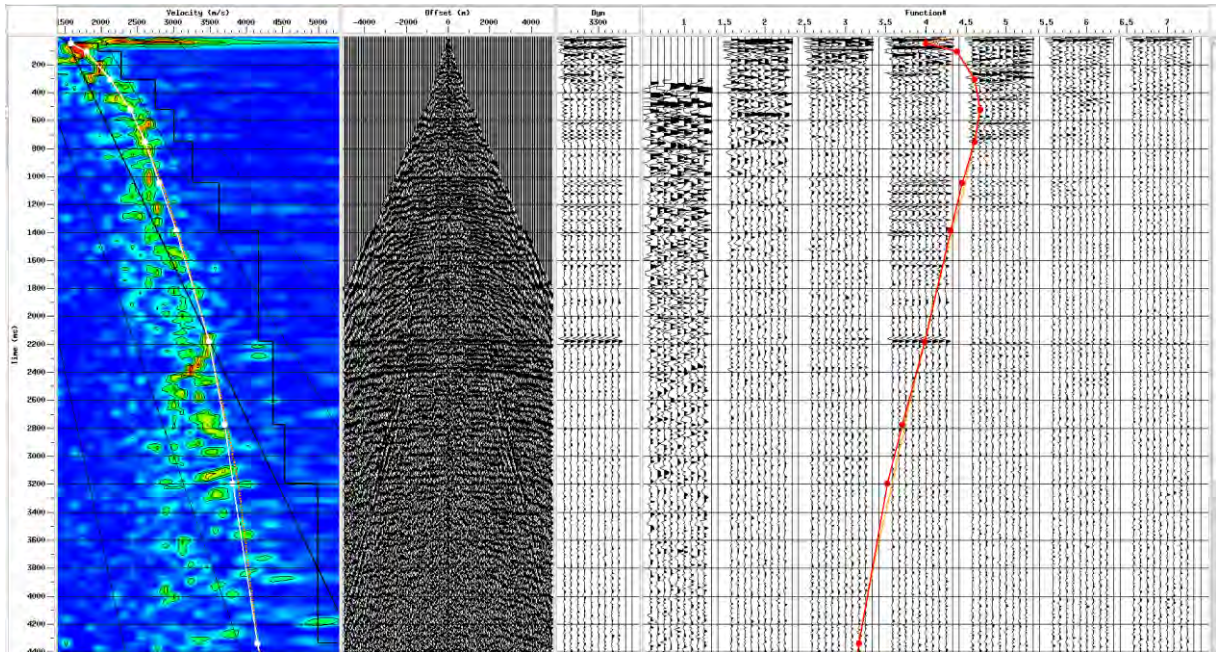
Figure 47. Typical velocity analysis panel along Line 12_01C

Interactive velocity analysis was carried out within the 2D seismic data of the acquired line. Detailed velocity samples were analysed at 500m intervals. An initial fixed guiding velocity function (1500 - 5000m /sec) was used for velocity picking. Velocity functions were then used to generate a brute stack at the end of each line. Picked velocity functions were exported in text format and included to the data shipment supporting documents.

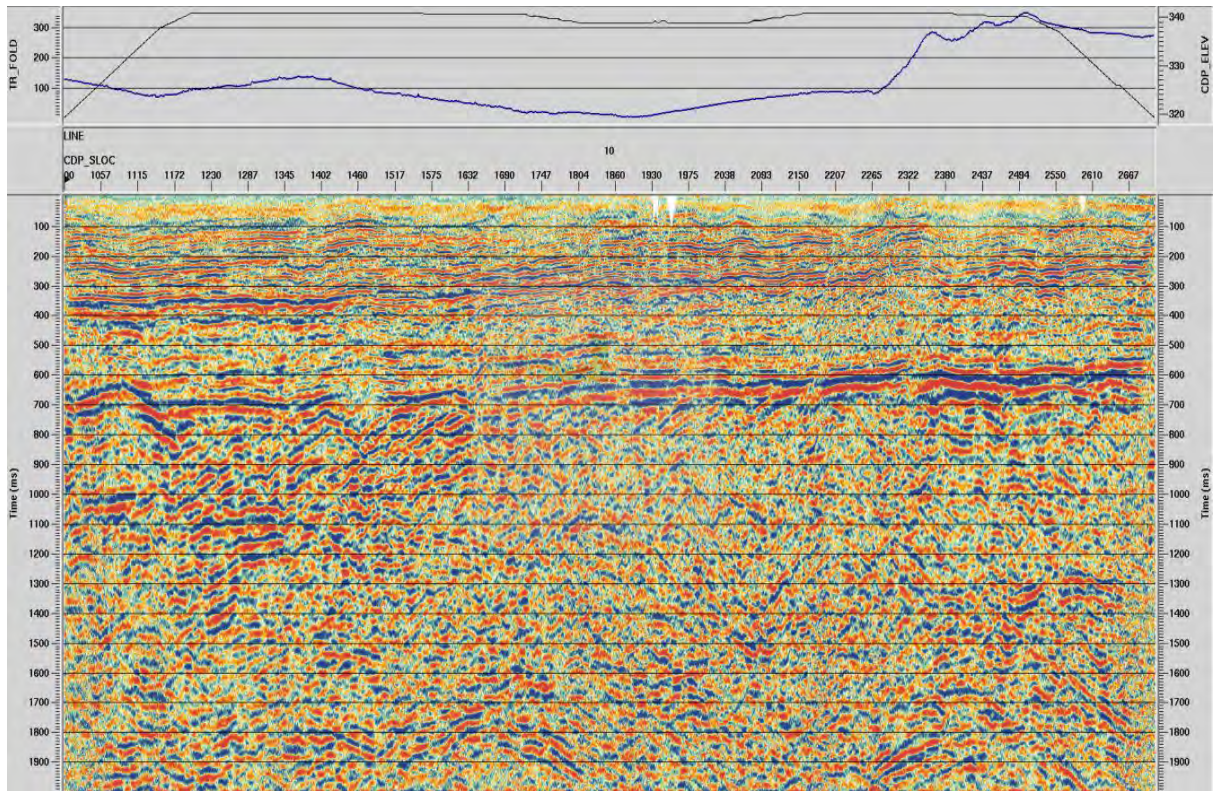
Figure 48. Field Brute Stack Line BEL12-010

The 2D field brute stacks of the acquired seismic data show continuous, coherent reflectors at the project's target two-way-travel (TWT) time approximately 1400 msec; and can also be traced down to 1800 msec in some sections of the lines. Many shallow reflectors can be also traced within the field stack images, particularly at 0 - 600 msec. Seismic data quality of the acquired 2D lines is excellent with a good signal-to-noise ratio and very high fold coverage. Traffic and ambient seismic noise were highly suppressed by the stacking algorithms. The noise that appears in the raw shot display gathers was generally collapsed in the field stacks.

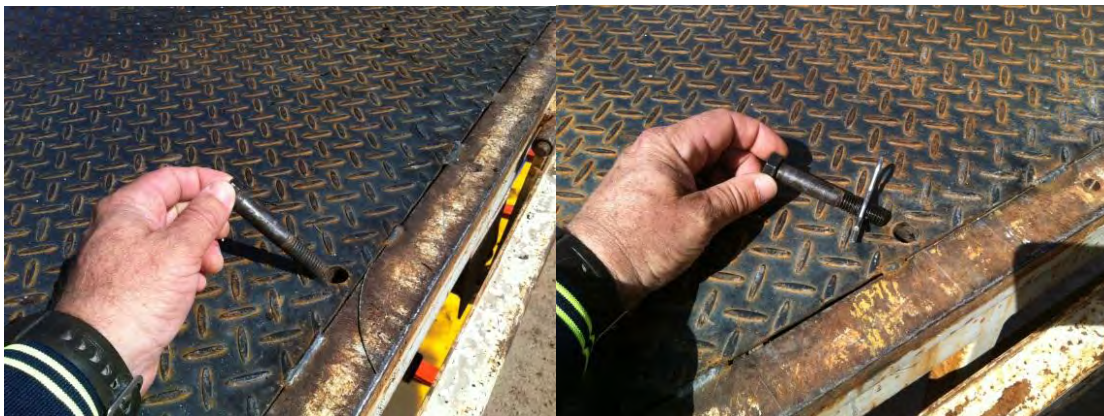
Figure 78. Ramp locking pin fitted to eliminate hazard

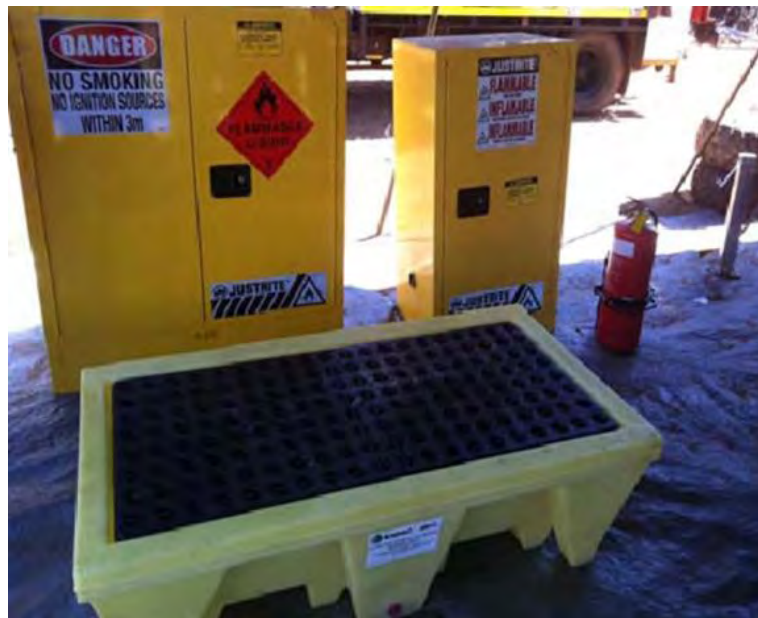
Figure 80. Spill Containment and Segregation

Spill response equipment was positioned at all points where fuels and oils were stored or transferred.

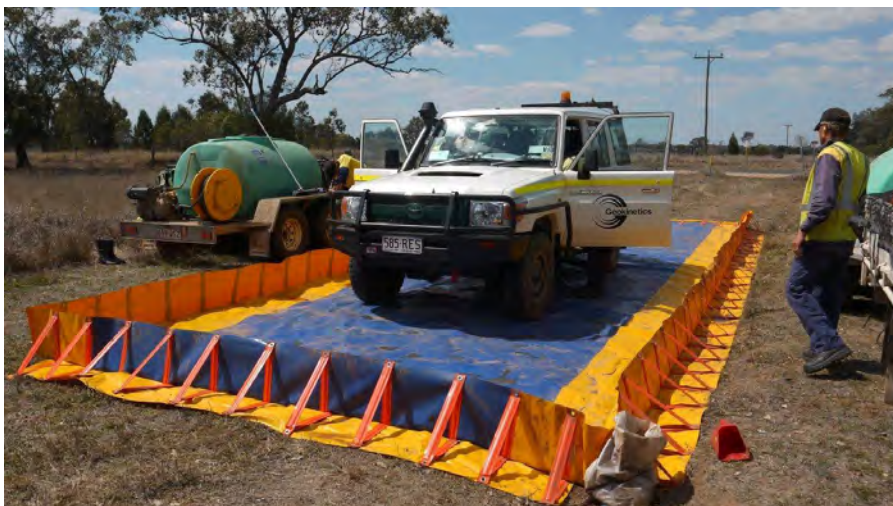
Figure 82. Crew Washdown Facility

Two Geokinetics owned mobile washdown units and one contracted unit conducted all washdown activities in the field while some vehicle washdowns were carried out in Meandarra. Washdown waste was filtered, collected, stored and disposed of in accordance to prescribed requirements.
