WELL ABANDONMENT REPORT
ATP 626P, SURAT BASIN, QLD
LYDIA 1

Date : 25/10/2013

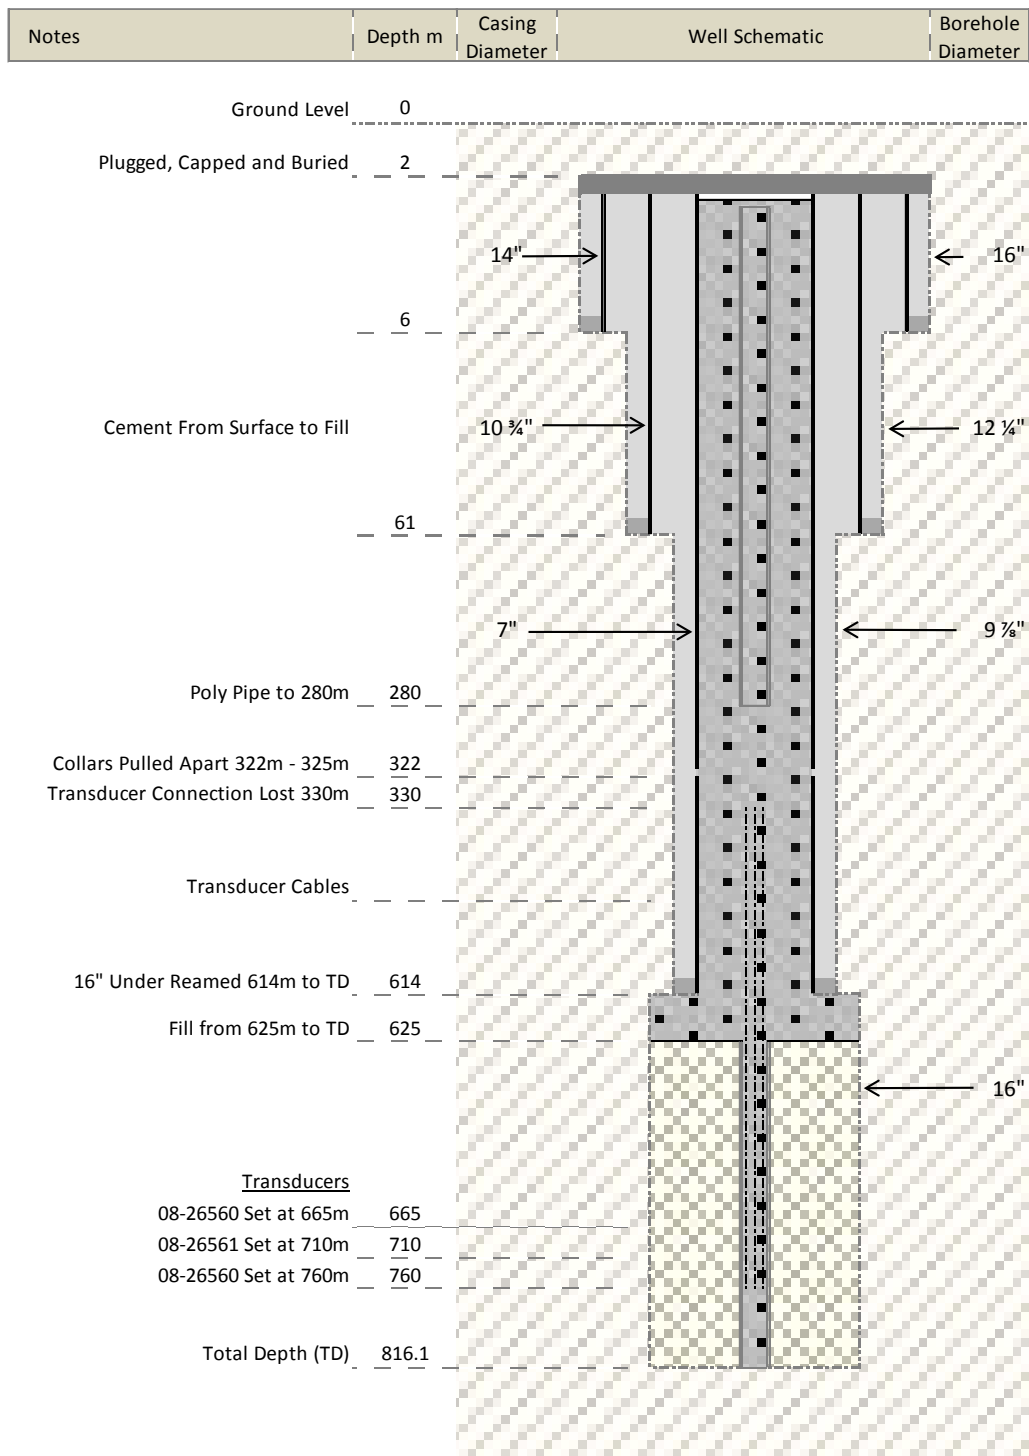
Figure 2 Well Profile of Lydia 1

The final hole profile of Lydia 1 is shown below.

HOLE SIZE (BIT)	DEPTH (m)	CASING SIZE (")	CASING TYPE	SETTING DEPTH (m)	MUD TYPE
16" (Auger)	0 – 6	14	Conductor	6	-
12 1/4" (PDC)	6 – 63	10 3/4	Surface	61	Water and Gel as required
9 7/8 (PDC)	61 - 614	7	Production	-	Water and Gel as required
6 (PDC)	614 - 816	-	-	-	Water and Gel as required
16 Under reamer	816 - 643	-	-	-	Water and Gel as required

Size (")	Type	Weight (lb/ft)	Number of Joints	Length (m)	Depth Set (mGL)	Cementing
14	Line Pipe	54.57	1	6	6	Cemented by hand.
10 3/4	Line Pipe		10	60	61	3m ³ Readymix, 15.6ppg. Top of cement tagged at 52m.
7	Buttress	23	102	614	614	10bbl water pre-flush. 160 sacks Class A 9% gel, 260 sacks Class A neat. Plug did not bump, float did not hold. Tagged cement bridge at 304m, hard cement at 608m.

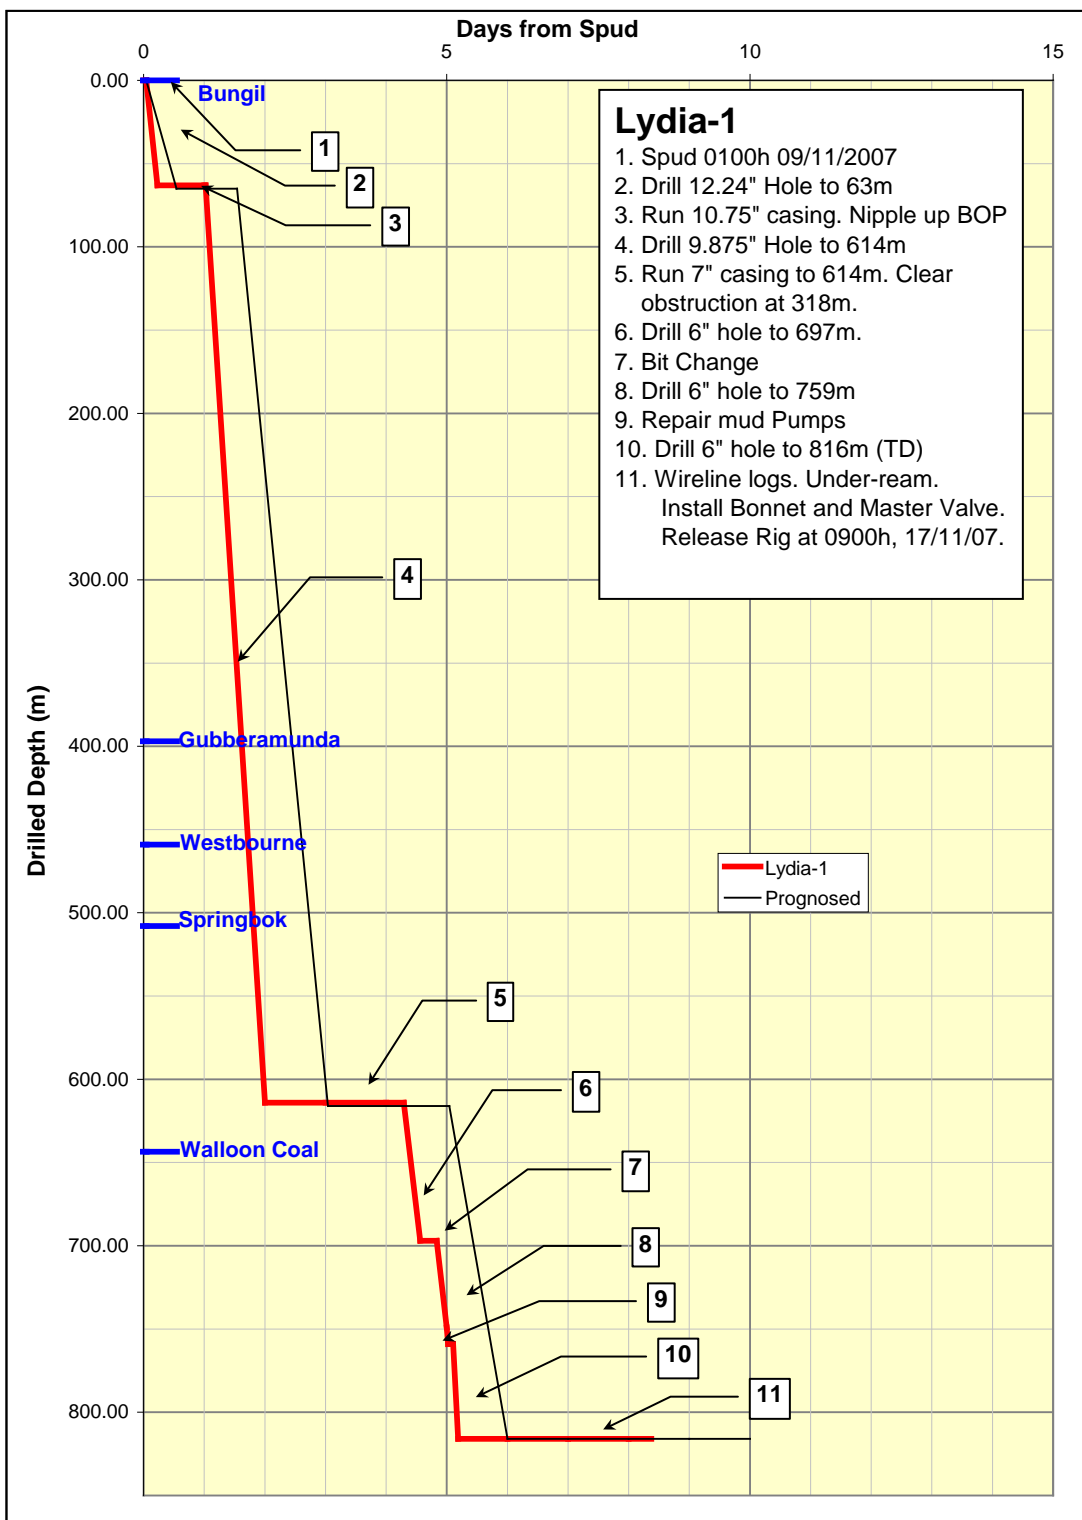
Figure 3 Time versus Depth Curve of Lydia 1

Lydia-1 took 8.33 days (200 hours) to complete with a total of 3 hours lost for rig repair of wash pipe and mud pumps. Another three hours were spent waiting on arrival of services.

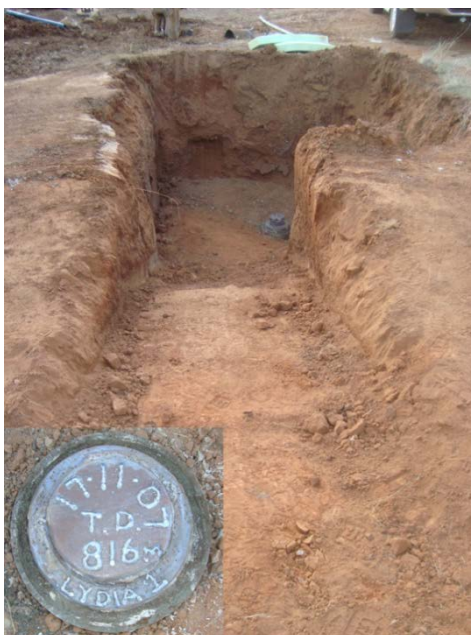
Figure 4 Lydia 1 Casing Sealed 1.5m below Ground

The photos of the drill site after all operations are seen below.

- 1) Bury casing stub and excavated cellar approximately 20 cm then add tiger tape. Continue filling excavated cellar and compact until 20 cm below ground level, add top soil and level off and re-seed as per landowner's instructions;
- 2) Ensure that the old sign is removed from the well guard and a new sign is placed on the fence at the nearest point to the well, with directions and distances from the fence to the wellhead;
- 3) Remove all redundant material (fence, wellhead) and return them to the warehouse. Finally clean and tidy up the site;
- 4) Acquire Landholder's signoff.
